Manhole Inspection Summary

Manhole # S19AA_001MH

Insp Date: **3/9/09 1:17 PM**

Location Address: **800 BRICE ST**

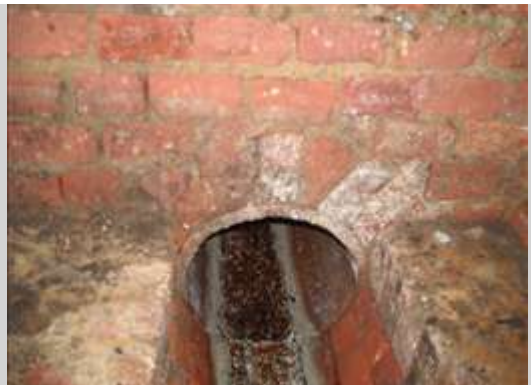
6 O'Clock Inflow

Pipe Height: **7.2** (in.) Rod and Bar (Angled)
Pipe Material: **Clay** ☐ Pipe Lined
Invert Depth: **9.23** (ft.) Flow Characteristics: **Slow**
Deposits: ☒ None ☐ Mud ☐ Sludge ☐ Debris ☐ Grease
Silt Depth: (in.) Deposits Extent:
Infiltration: **None** Pipe Seal Cond: **Sound**

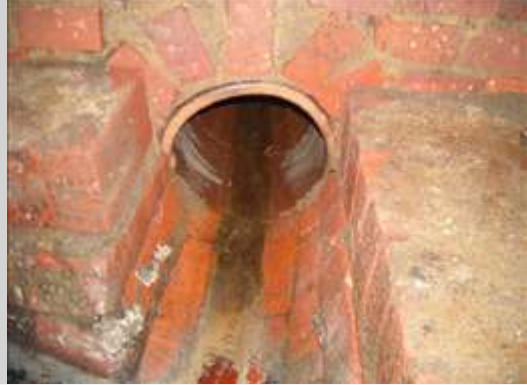
9 O'Clock Inflow

Pipe Height: **7.2** (in.) Rod and Bar (Angled)

Infiltration: **None** Pipe Seal Cond: **Sound**
